LAKE CLASSIFICATION SHORT REPORT ON PATRICK LAKE, ADAMS COUNTY, WI

Presented by Reesa Evans, Lake Specialist Adams County Land & Water Conservation Department P.O. Box 287, Friendship, WI 53934

OCTOBER 2007

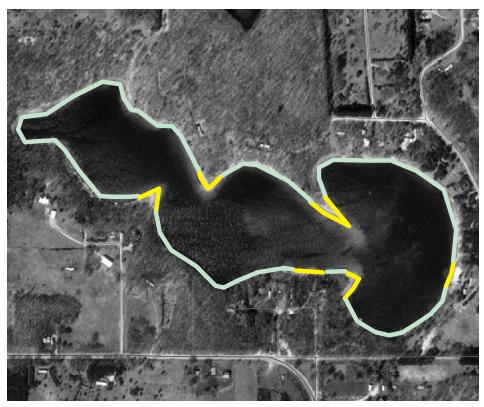
Patrick Lake Shoreline

Patrick Lake has a total shoreline of 1.68 miles (8870.4 feet). Much of the shore in the northwest lobe and in the west part of the center lobe of the lake has been left mostly undisturbed. Buildings in these areas tend to be uphill and more than 70' from the shore.

The eastern lobe of the lake is in residential use and park use. Most of the areas in this lobe are flatter than the northwest end. Buildings in this lobe are generally located closer to the shoreline than those on the west part of the lake. 80% of Patrick Lake's shoreline is vegetated.

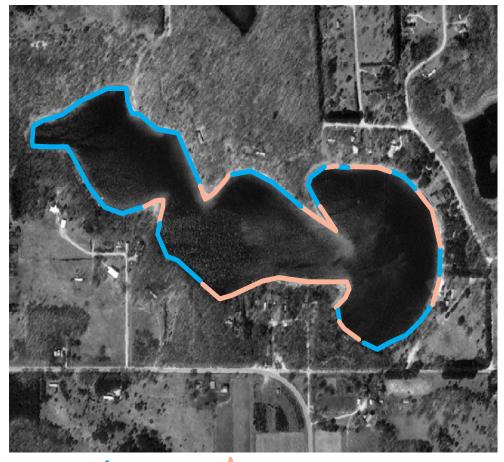
Patrick Lake--Buffers

A 2004 shore survey showed that most of the shore had an "adequate buffer." An "adequate buffer" is a native vegetation strip at least 35 feet landward from the shore.

However, there were still areas of "inadequate" buffers, mostly those with mowed lawns and insufficient native vegetation at the shoreline to cover 35 feet landward from the water line. There are also several areas of sand bars and some active erosion.

- Shores with inadequate buffers may need to restore the buffers to an adequate condition to provide winter habitat for these weevils, as well to assist in maintaining water quality.

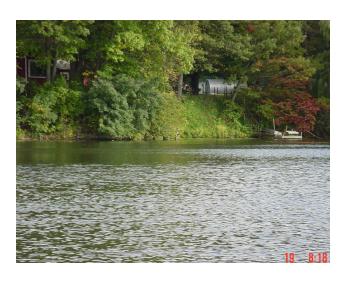
Example of Adequate Buffer

Vegetated shoreland buffers help stabilize shoreline banks, thus reducing bank erosion. The plant roots give structure to the bank and also increase water infiltration and decrease runoff. A vegetated shore is especially important when shores are steep and soft, as are many of the Patrick Lake shores.

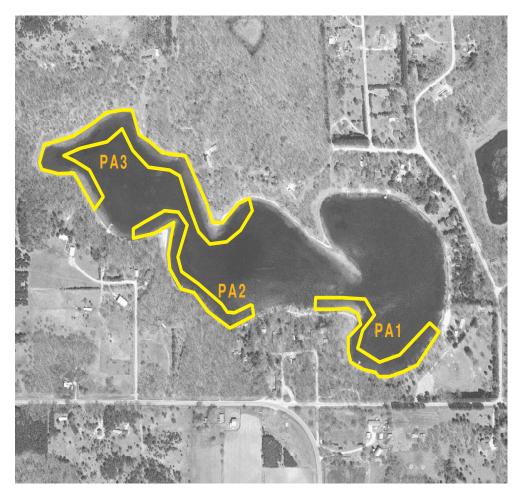
Three areas on Patrick Lake were determined to be appropriate for critical habitat designation. PA1 extends along approximately 800 feet of the southeastern shoreline of Patrick Lake, up to the ordinary high water mark. PA2 extends along approximately 1000 feet in the middle of the southern shoreline. PA3 covers 1650 feet of the western end of the lake.

- Maintain current habitat for fish and wildlife with as little disturbance as possible.
- Leave fallen trees along shoreline & in water.
- Seasonal protection of spawning habitat. No disturbance of littoral zone except for authorized viewing/access corridor or WDNR-approved projects.
- Maintain the wildlife corridor.
- Protection emergent vegetation.
- Seasonal and specific control of exotics.
- No bank grading or grading of adjacent land. If shore erosion present, use bioeingeering rather than rock or similar hard structure.
- Maintain aquatic vegetation in undisturbed condition for wildlife habitat, fish use and water quality protection.
- Any new piers installed should be of material that allows light penetration to the lake bottom.
